Implementing an Acoustic Pipe Inspection Program Using the
Sewer Line Rapid Assessment Tool
A Case Study on the City of Augusta

Alex Churchill – InfoSense
Jody Crabtree – Augusta
Kevin Joyner – Augusta

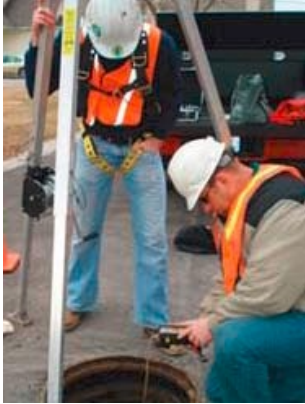
- ▶ Manhole Inspection

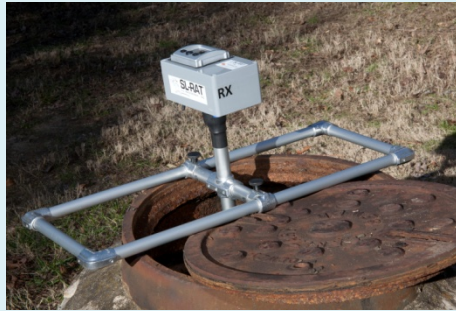
- ▶ *Acoustic*

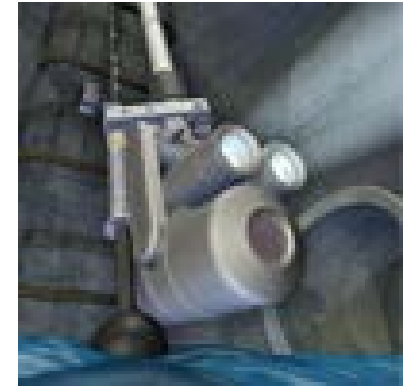
- ▶ Zoom Camera

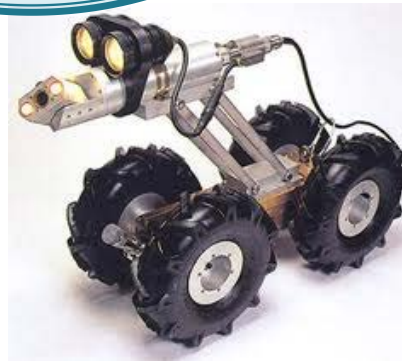
- ▶ CCTV/Robotic Camera
- ▶ Pipe Wall Defect Scanners
- ▶ Pipe Profiling / Robotic Multi-Sensor

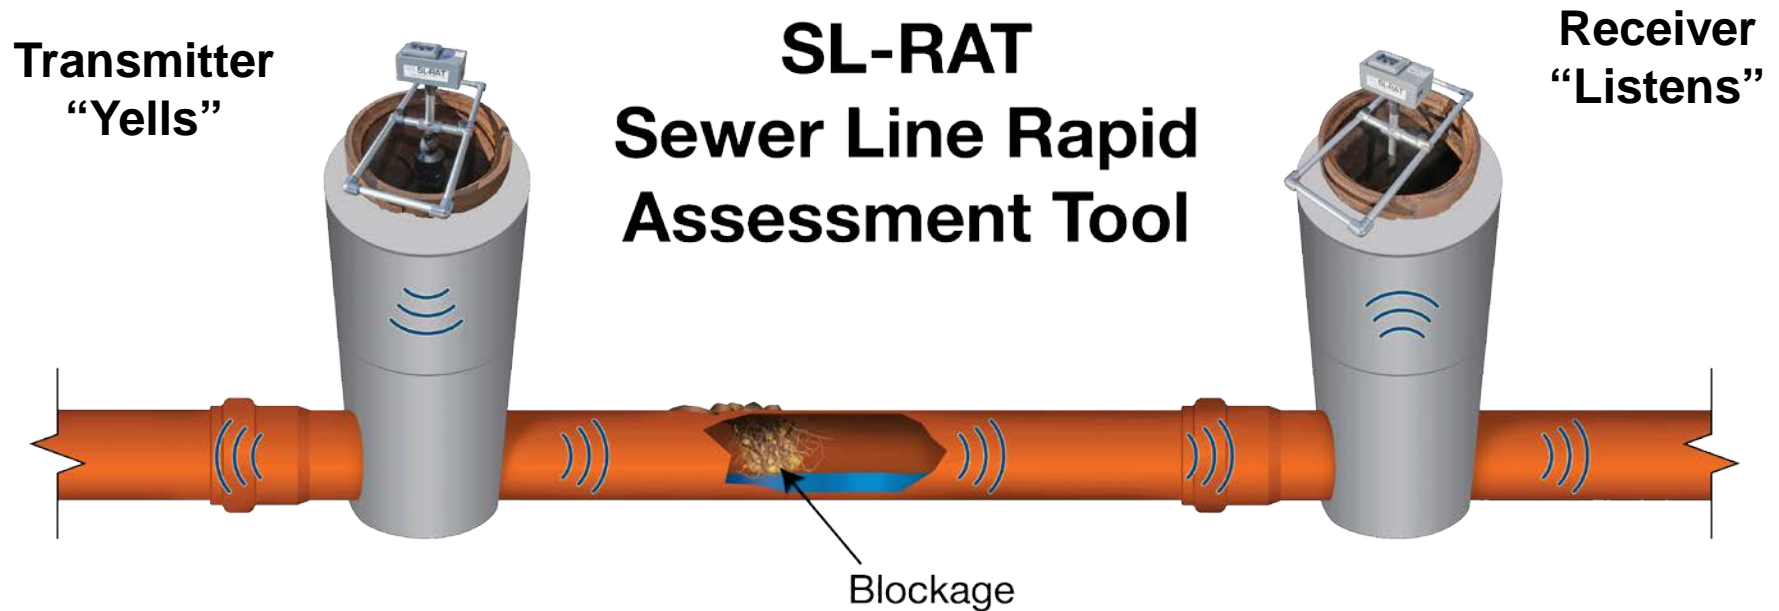
Acoustic Inspection Technology

- ▶ How Does it Work?

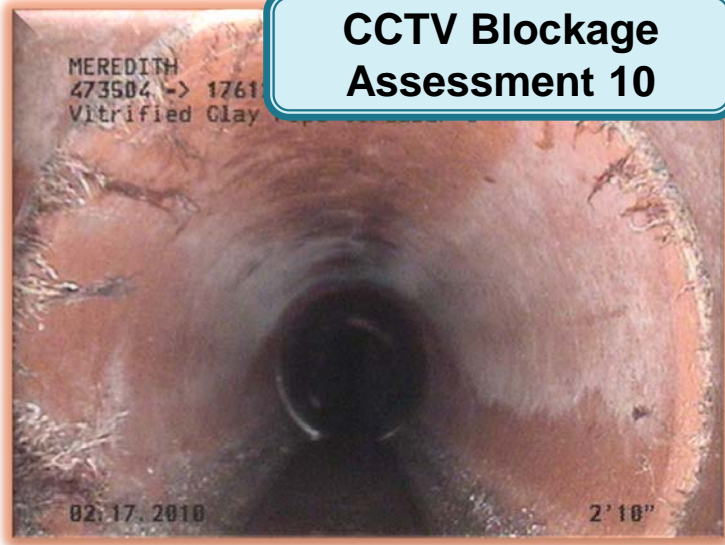
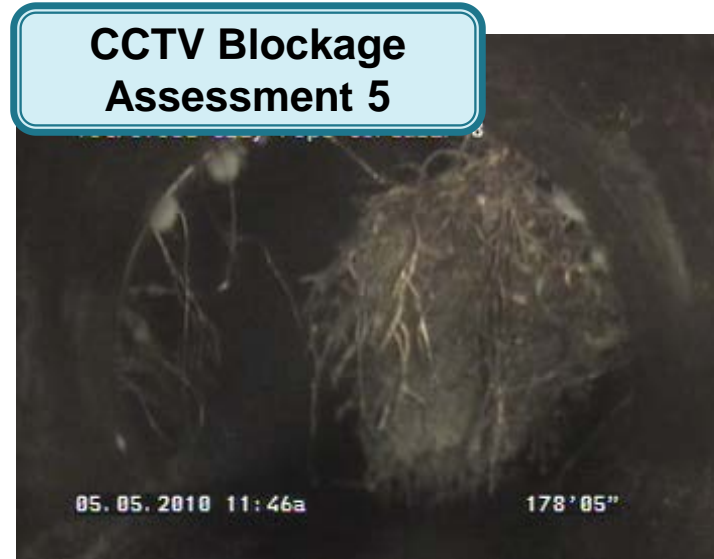
CCTV Robot was Able to Pass Through Root Fibers

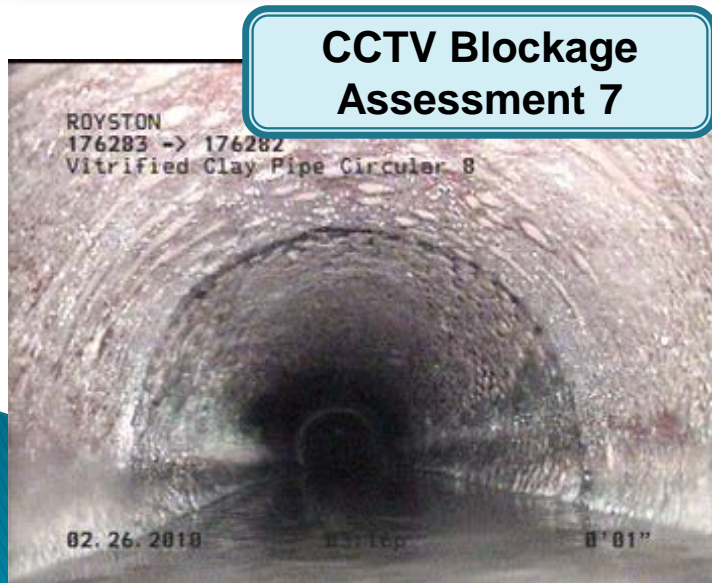
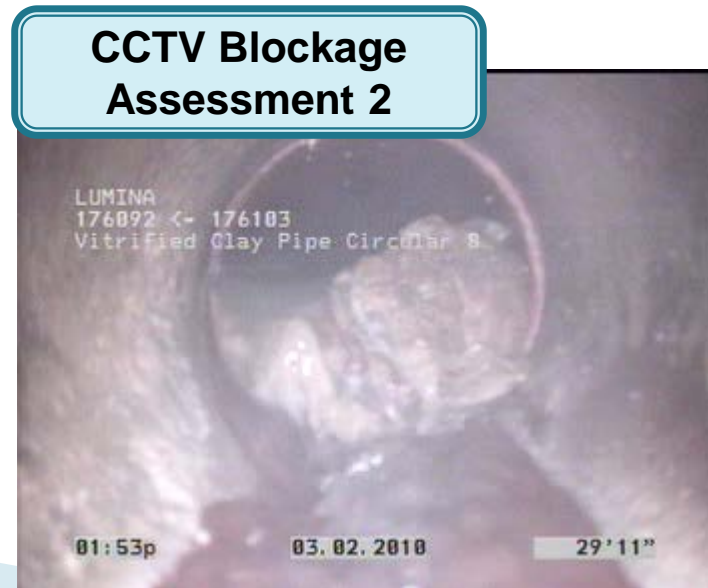
CCTV Robot was Not Able to Pass Through Obstruction

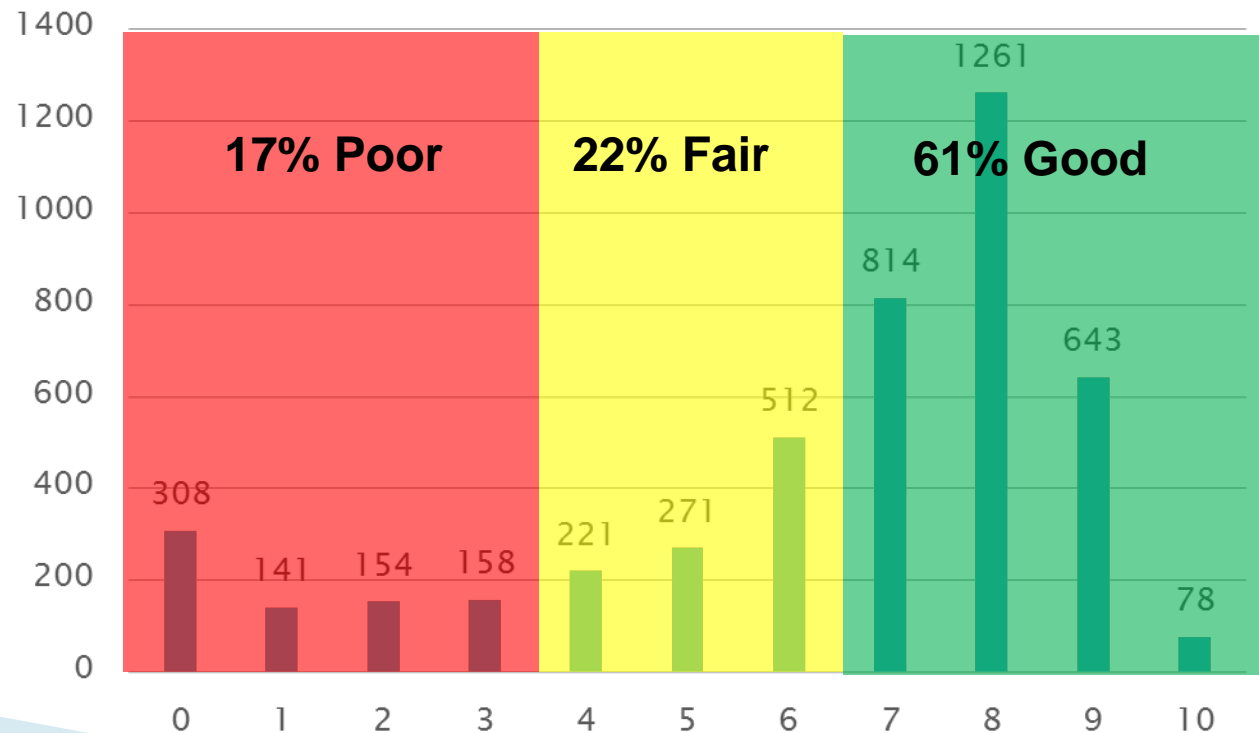
Histogram of Acoustic Scores

1. The SL-RAT is simple, reliable, and easy to use
2. Keep up with the data – DAILY! Backlogs can get overwhelming
3. Forces discipline in visiting every manhole – identify issues, update GIS records, etc
4. Has focused efforts on the 39% of segments that are Poor or Fair
5. Requires teamwork to achieve full potential – cleaning crews, GIS, inspection crews – must all work together
6. Future plans include conducting post-cleaning QA
