# **IMPLEMENTATION OF ACOUSTIC INSPECTION TECHNOLOGY**

**AT THE CITY OF AUGUSTA**

**NASTT's 2015 No-Dig Show**

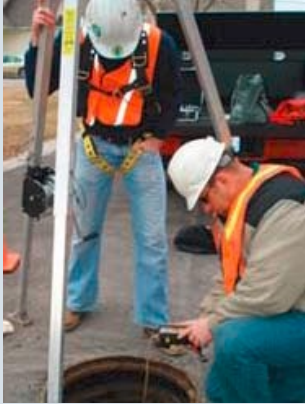
▶ Manhole Inspection

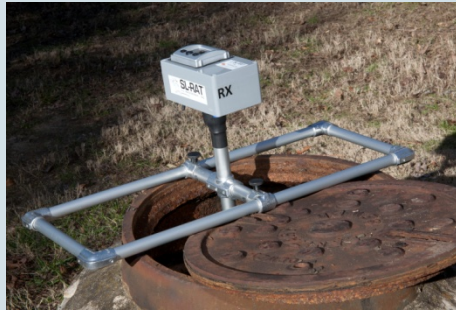
▶ *Acoustic*

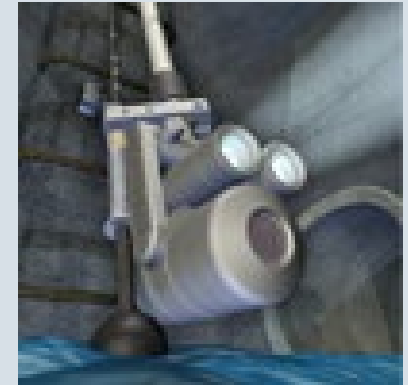
▶ Zoom Camera

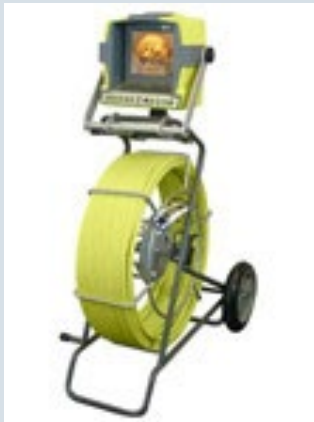
▶ Push Camera

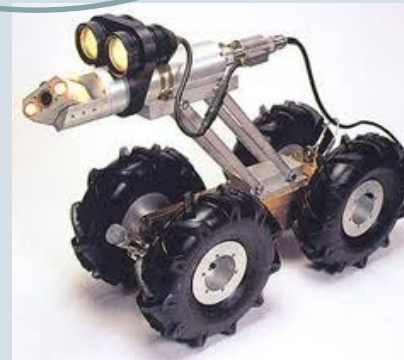
▶ CCTV/Robotic Camera, etc

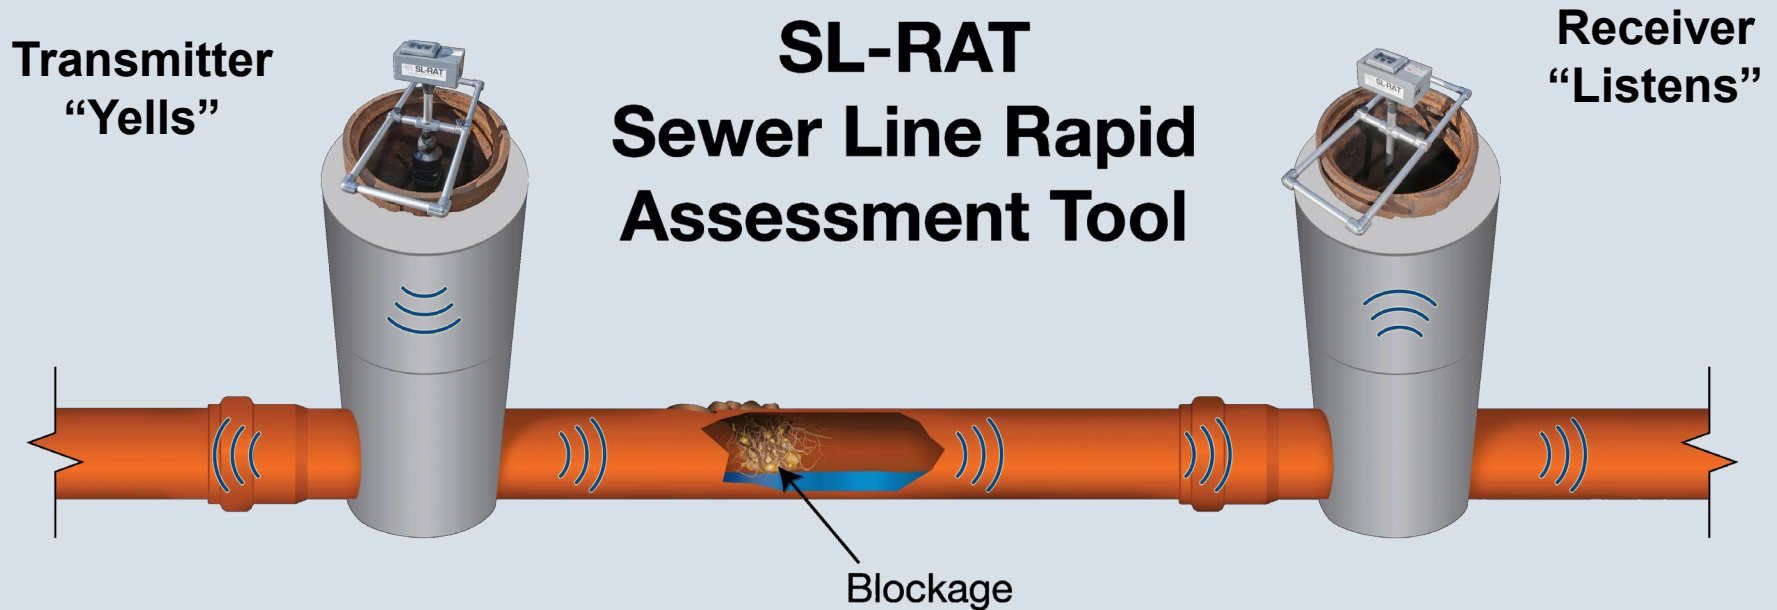
# ACOUSTIC INSPECTION TECHNOLOGY

- How Does it Work?

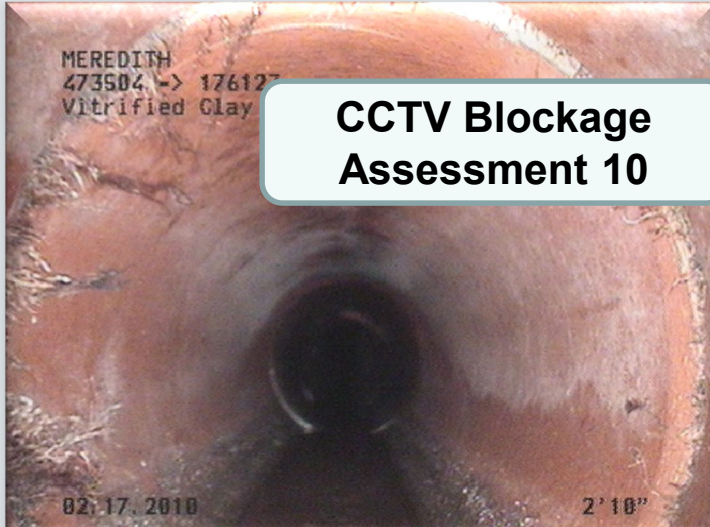
**CCTV Blockage Assessment 10**

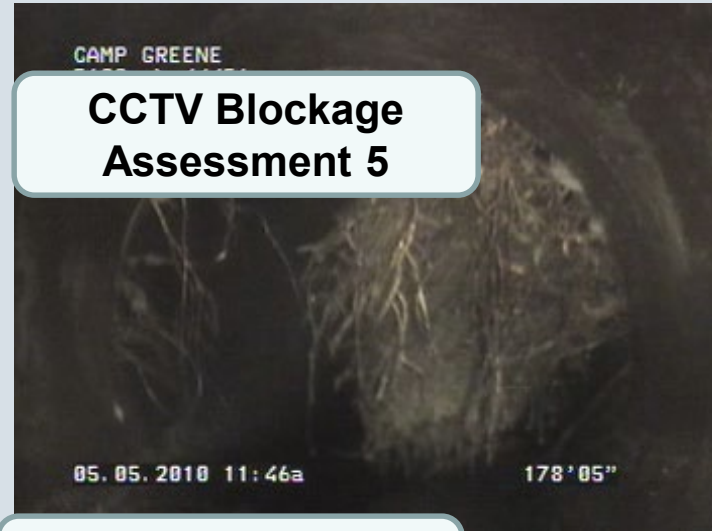
**CCTV Blockage Assessment 5**

**CCTV Robot was Able to Pass Through Root Fibers**

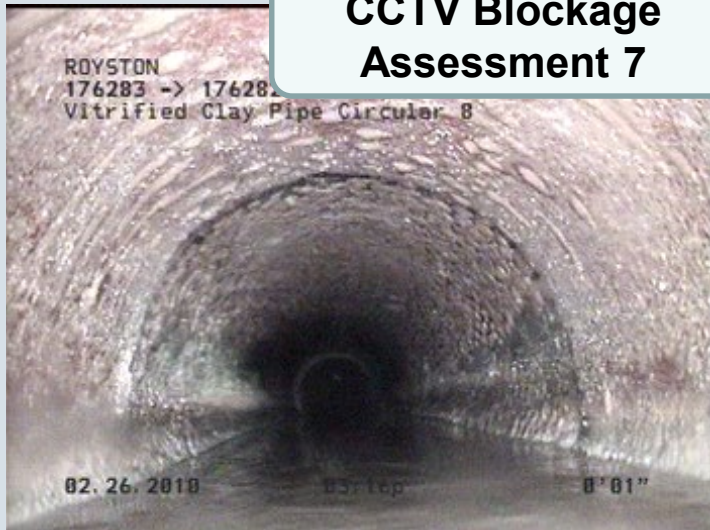
**CCTV Blockage Assessment 7**

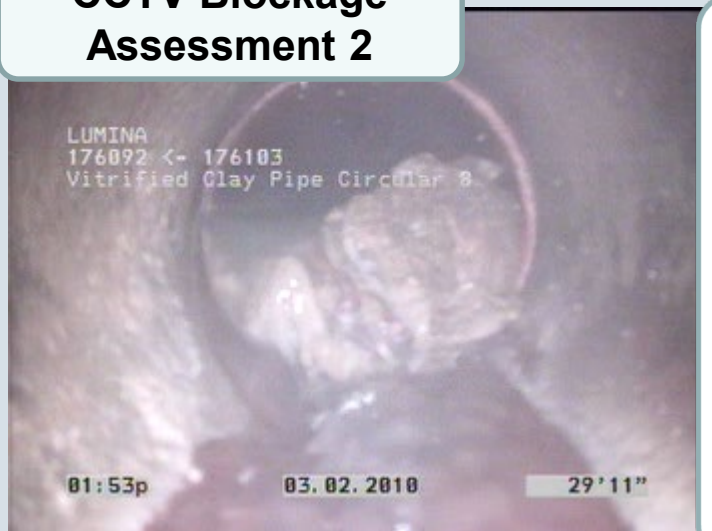
**CCTV Blockage Assessment 2**

**CCTV Robot was Not Able to Pass Through Obstruction**

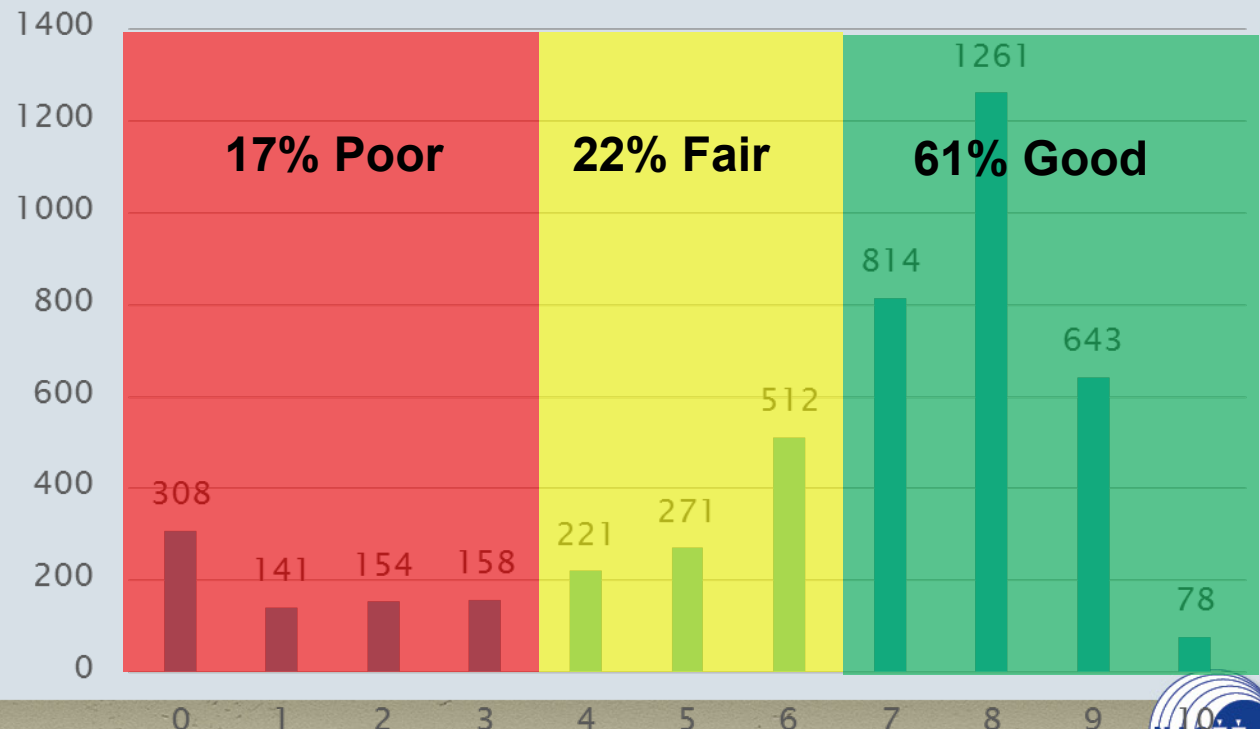
- >4,500 segments inspected in ~9 months of work
- >9,000 manholes located and inspected
- >1 MILLION Feet (197 miles)

## Histogram of Acoustic Scores

1. The SL-RAT is simple, reliable, and easy to use
2. Keep up with the data - DAILY! Backlogs can get overwhelming
3. Forces discipline in visiting every manhole – identify issues, update GIS records, etc
4. Has focused efforts on the 39% of segments that are Poor or Fair
5. Requires teamwork to achieve full potential – cleaning crews, GIS, inspection crews – must all work together
6. Future plans include conducting post-cleaning QA
