Use of Acoustic Inspection for Prioritizing Renewal and Replacement Projects at Ft. Jackson, South Carolina

ABSTRACT

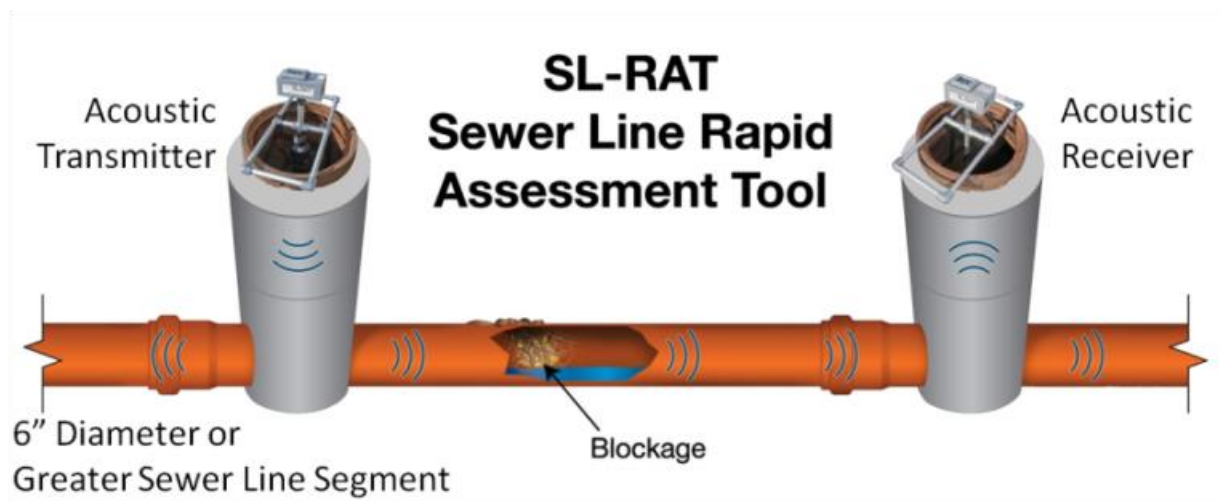
Figure 1. Operation of the Acoustic Inspection System

The Sewer Line Rapid Assessment Tool (SL-RAT™) utilizes acoustic technology to quickly assess the degree of blockage in a sewer line (Howitt, 2012). Using this assessment tool to estimate pipe segments' useful life could provide a breakthrough enhancement for prioritizing R&R projects. The SL-RAT exploits the similarities between water and sound transmission through a sewer line segment in order to diagnose the extent of the pipe's blockage. This novel, patented methodology is based on measuring the signal received from an active acoustic transmission through a segment. Figure 1 depicts the general configuration of the SL-RAT device. The acoustic transmitter generates sound waves just below the entrance to the manhole which naturally couple into connecting sewer line segments, whether the depth of the manhole is 1 meter or greater than 10 meters. The sound wave propagates in the air gap above the wastewater flow from the speaker to the receiving microphone located at the adjacent manhole. Segment lengths exceeding 250 meters have been successfully evaluated. The acoustic receiver measures the acoustic plane wave from the transmitted signal in order to evaluate the condition of an entire segment and provides an onsite assessment in less than three minutes. An important practical aspect of the SL-RAT is that both the speaker and the microphone are placed just within the opening of the manhole and never come in contact with the wastewater flow and the operators have no requirement for confined space entry.

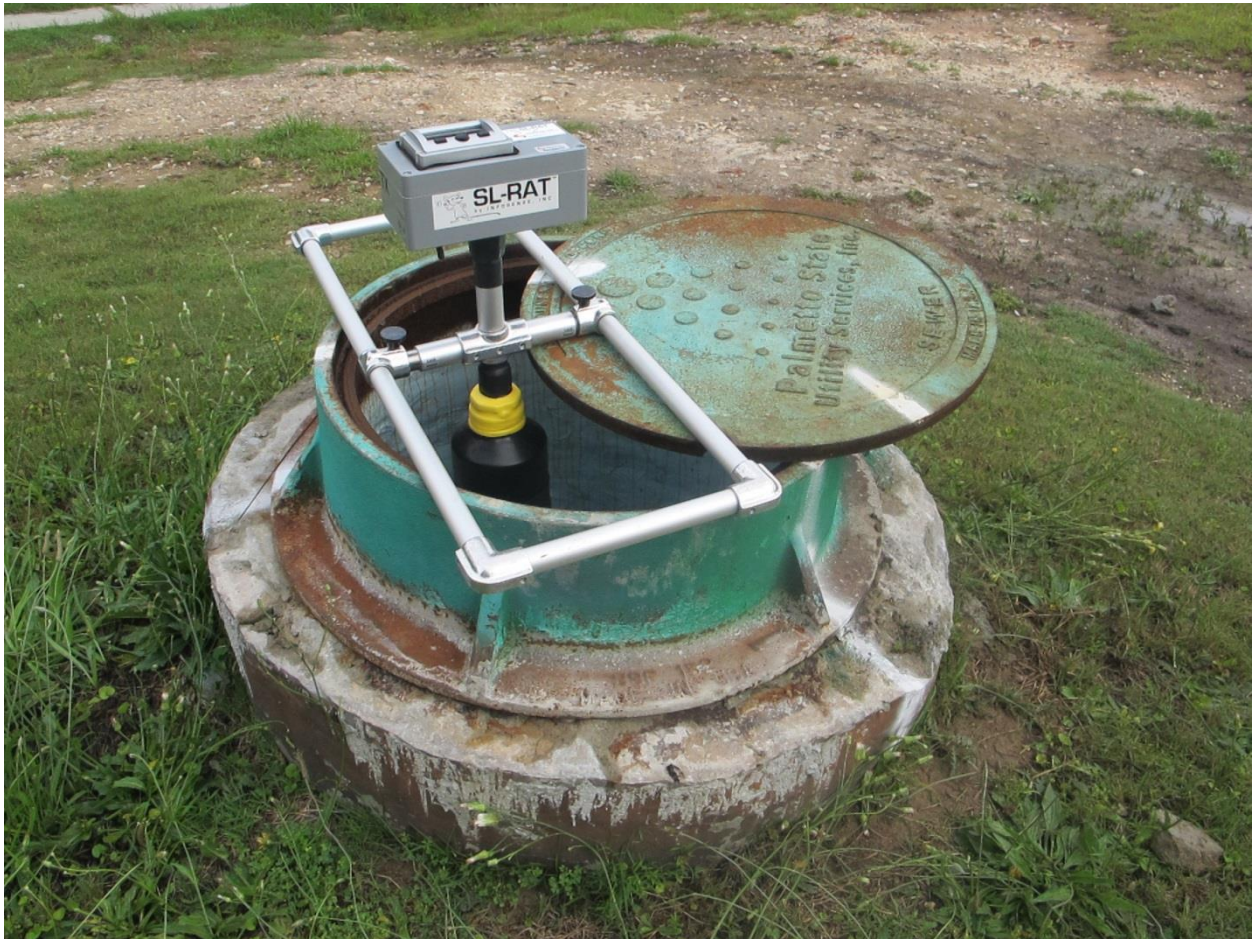
Figure 2. SL-RAT Transmitter Unit Deployed on a Manhole

SL-RAT acoustic inspection measurements were conducted on May 16, 2012. Figure 2 shows a typical configuration for an SL-RAT transmitter unit (speaker). The receiving unit (microphone) was set on an open manhole (in a similar fashion) at the other end of the sewer line segment. Typical acoustic inspection time was between 1.5 to 3 minutes once the manhole lids were removed. CCTV video was taken in the six months prior to the acoustic inspection.

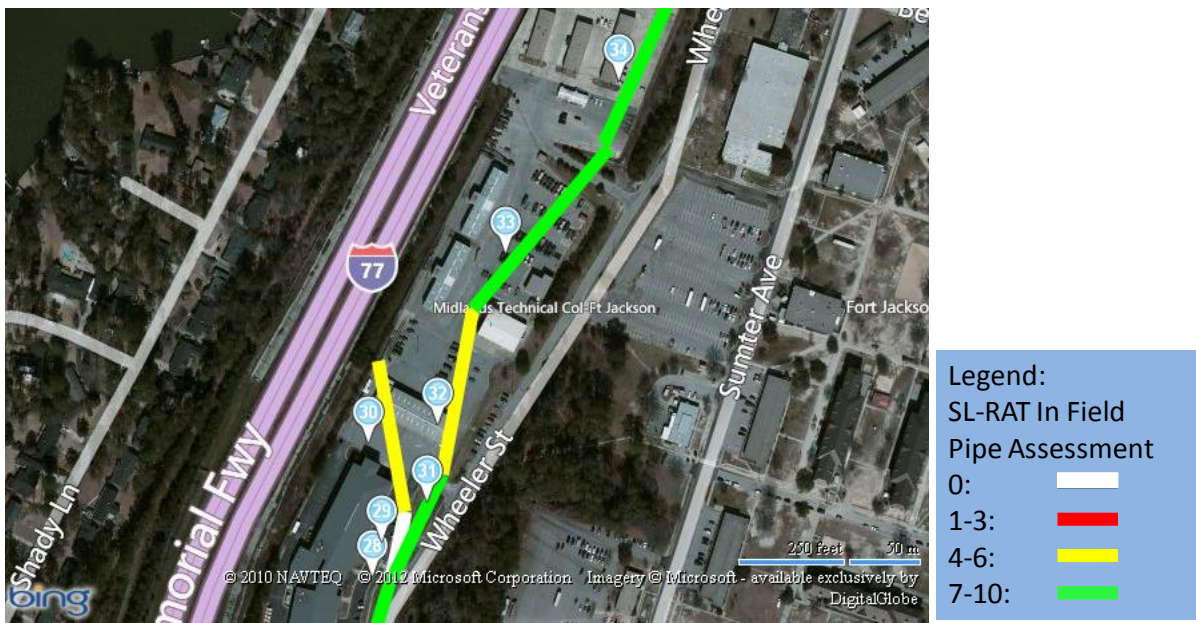
Figure 3. SL-RAT acoustic classification results overlaid on GIS map.

Results are presented in Tables 1 and 2, and maps of the acoustic assessments are shown in Figures 2 through 4. Sewer line segment classification (i.e., color code) is based on the SL-RAT measurements and is based on the default classification scheme as defined in the legend. These classifications were based algorithms developed for 15-30cm (6-12 inch) pipe. Note that all pipes for this inspection campaign were larger (45.7-61cm, or 18-24 inch).
