Implementing an Acoustic Pipe Inspection Program Using the
Sewer Line Rapid Assessment Tool
A Case Study on the City of Augusta

Alex Churchill - InfoSense Jody Crabtree - Augusta Kevin Joyner - Augusta

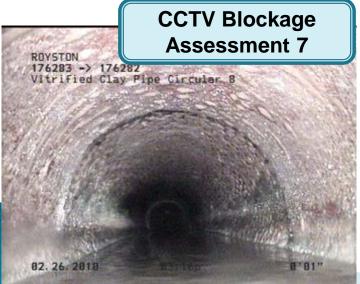
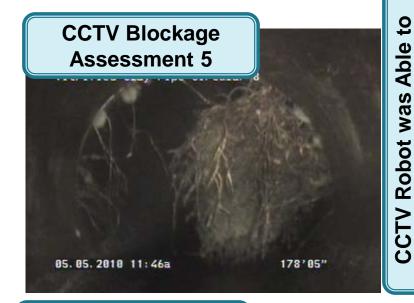
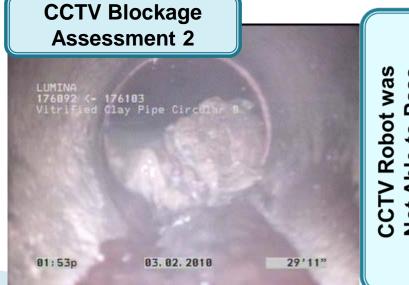
Visual Comparison

CCTV Robot was Not Able to Pass Through Obstruction

Root Fibers
