# Demonstration of Innovative Sewer System Inspection Technology: SL-RAT™

Contract No. EP-C-11-006

National Risk Management Research Laboratory  
Office of Research and Development  
U.S. Environmental Protection Agency  
Cincinnati, Ohio 45268

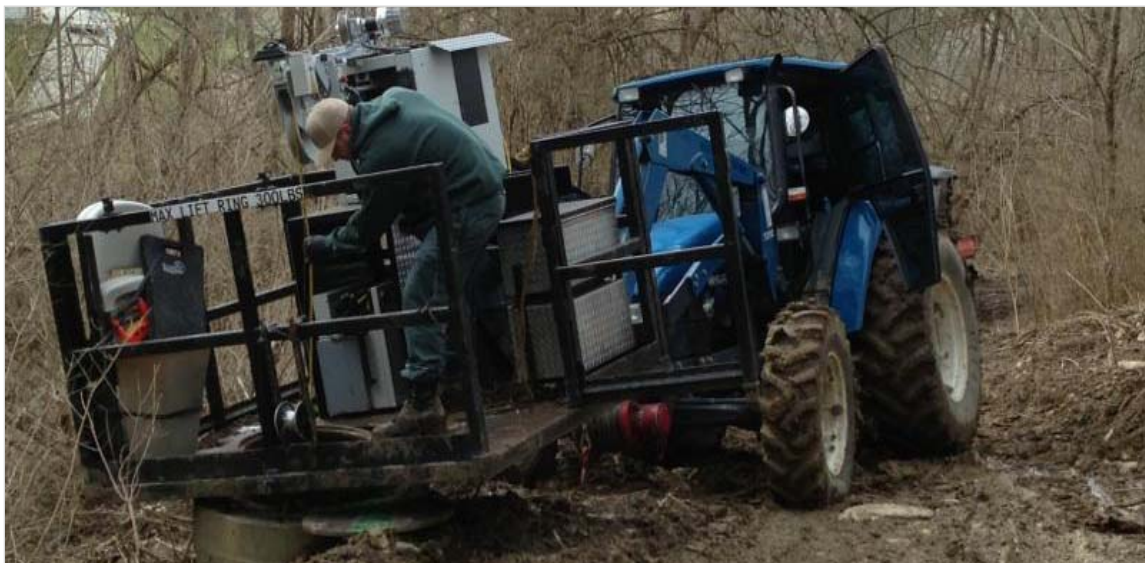
**Figure 1-1.** Custom Off-road CCTV Camera Tractor (Courtesy: MSDGC).

The most common type of robotic CCTV inspection systems in use for inspection of public sewers requires vans, trucks, or similar vehicles for their operation. If sewers are located off-road, all wheel drive or four wheel drive vehicles may be required to access the manhole structures. A new vehicle equipped with a CCTV inspection system will typically cost between \$100,000 and \$200,000, and require a minimum crew of two persons. Custom off-road vehicles equipped with CCTV systems are even more expensive to own and operate. Figure 1-1 shows a custom off-road CCTV camera tractor owned and operated by the Metropolitan Sewer District of Greater Cincinnati (MSDGC).

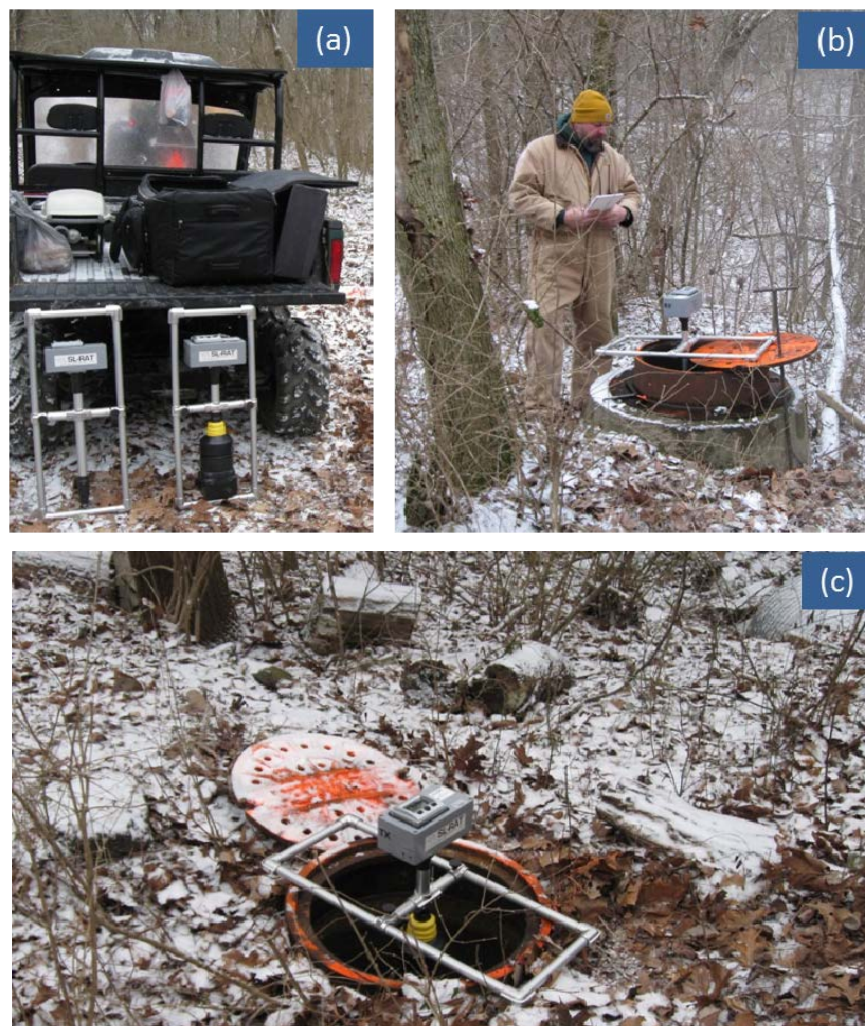
**Figure 1-3.** SL-RAT Deployment at EPA Project Site: (a) TX and RX Units in Transport Mode, (b) RX Unit Operational Mode Deployment, (c) TX Unit Operational Mode Deployment.

time and allows the units to be ready for operation. Figure 1-3(a) shows the SL-RAT units in their transport mode at one of the EPA study sites. To perform an acoustic inspection with the SL-RAT, the manhole covers at both ends of a pipe section are either partially or fully removed. The SL-RAT units are then placed in their operational mode as depicted in Figure 1-3(b) and (c) for the RX and TX units, respectively. For off-road or on-road inspections, the SL-RAT can be easily transported manually with the RX unit weighing 11 pounds and the TX unit weighing 18 pounds. Typical usage involves inspecting multiple pipe segments along a leg of a sewer line. This is facilitated by only moving one unit at a time after each inspection (effectively “leap frogging” the units down the sewer line). Tests are conducted while the pipe is in operation, with no need to restrict or change the flow conditions. The units can be deployed for testing in either the upstream or downstream direction.

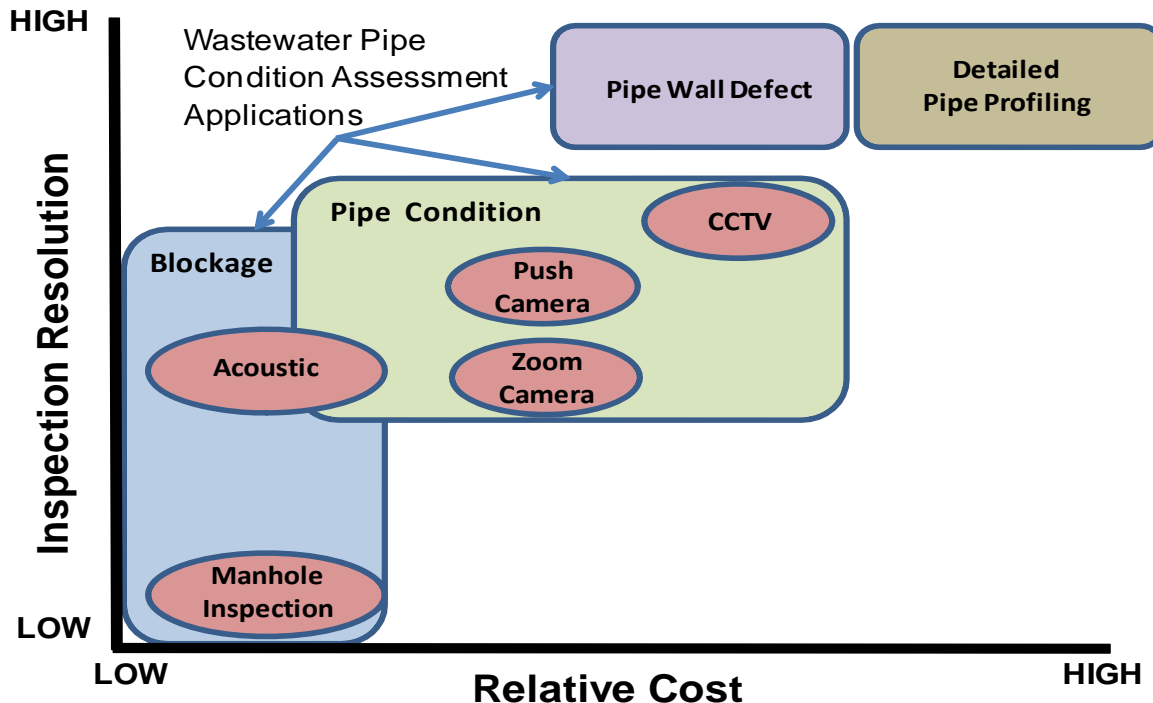
Figure 4-1. Sewer Pipe-Condition Assessment Tools (Adapted from: InfoSense, 2013).

Overall, the use of SL-RAT as a pipe-condition assessment tool needs to be evaluated in context with the existing tools available to wastewater utilities. Figure 4-1 presents a graphic summary of where the SL-RAT as a sewer pipe inspection tool is likely to fit into a wastewater utility's "tool-box."
